10 World Conference on Neutron Radiography 5-10 October 2014

Non-destructive investigation of “The Violinist” a lead sculpture by Pablo Gargallo, using the neutron imaging facility NEUTRA in the Paul Scherrer Institute

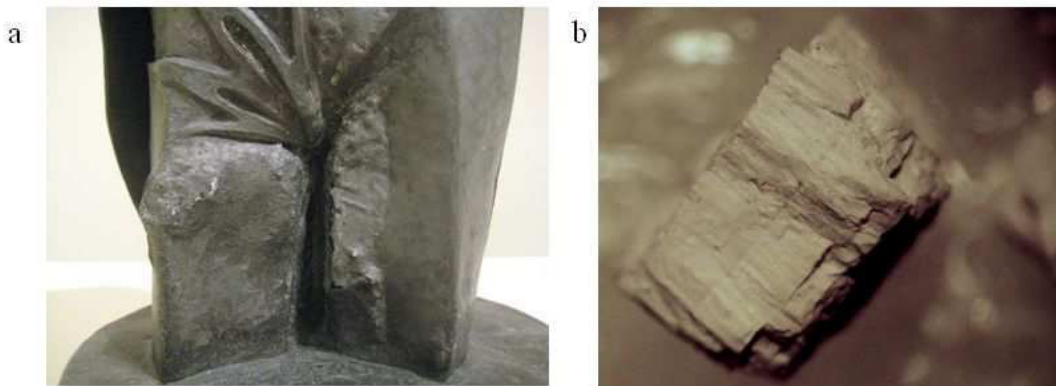
On the other hand, some years ago different swollen areas on both legs of The Violinist were noticed for the first time (Fig. 2a). With time these areas grew larger and higher, and began to open up while a white substance began to show through. In order to identify its composition different samples were taken from the swollen areas on both legs (Fig. 2b), filling with synthetic stucco the hole left by sampling. The results from the chemical analysis confirmed the presence of basic lead carbonate hydrocerussite. During the last two years there appeared more areas swelling up and the process seems to be speeding up. New blisters can also be found at the back of the neck, on the right shoulder, on the left hip and between both legs. The sculpture, which had been on show in the permanent

Lead and wood are two non compatible materials. Lead is often affected by corrosion when used in combination with wood (Graedel, 1994; Hallebeek, 1994; Tetreault et al., 1998). Lead can be attacked by emitted volatile organic compounds (VOCs) such as formaldehyde, formic and acetic acids coming from some timbers, polyvinyl acetate (PVA) wood-glue and medium density fibreboard (MDF) binders. These organic compounds, and specially acetic acid, transform lead into lead carbonate which is the white, granular powder we see showing through the blisters on the legs (Fig. 2b).

Fig. 2. (a) Plastic deformation on both legs due to advanced lead carbonate corrosion; (b) macrophotography of sample of lead carbonate taken from the blister in the left leg. The fine parallel lines grow with every new layer of lead carbonate formed most probably due to an increase in relative humidity.

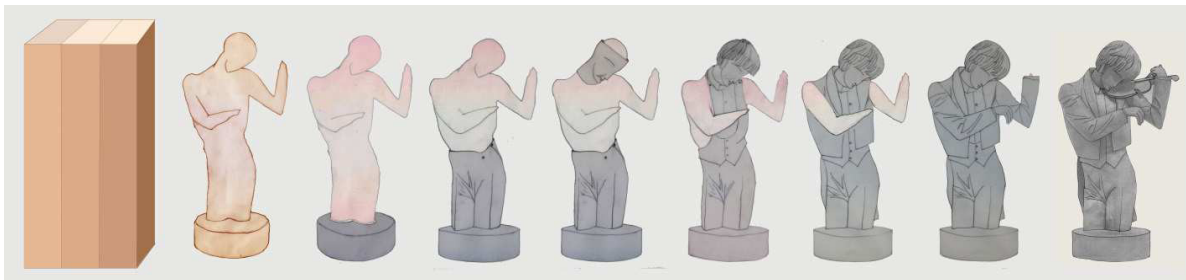
Once all the pieces of lead, the solders and the nails were identified it was possible to make an attempt to trace the manufacturing technique of the artist (Fig. 6). Gargallo first glued the block of wood, then carved the body and base in one piece, then began to fix lead pieces with nails and solder, little by little covering the nails with every new layer of lead sheet, and soldering the final pieces so as not to leave any visible nails.

Fig.6. Hypothetical steps followed by Gargallo during the construction of The Violinist.

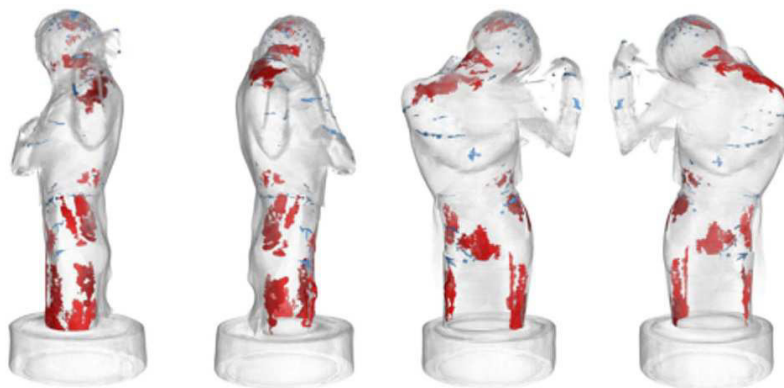
Fig. 7. Mapping showing corroded areas (in red) inside the lead sheet, remains of flux and nails (blue) according to the information given by the tomograms.

In tomography the lead carbonate layers appear as a fine white band attached to the inside of the lead sheets. They can sometimes be confused with the remains of flux in the soldering. The accurate and thorough analysis of the tomographic images can help us obtain quite an accurate mapping of the areas affected by carbonation (Fig. 7) and thus estimate the percentage of the total internal lead surface affected which is about 10 to 15%.
